Manhole Inspection Summary

Manhole # S43E__062MH

Insp Date: **6/11/08 9:42 AM**

Location Address: **side 1721 e baltimore st**

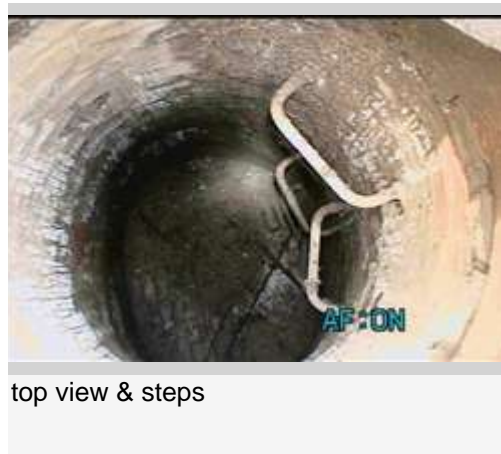
Top View

top view & steps

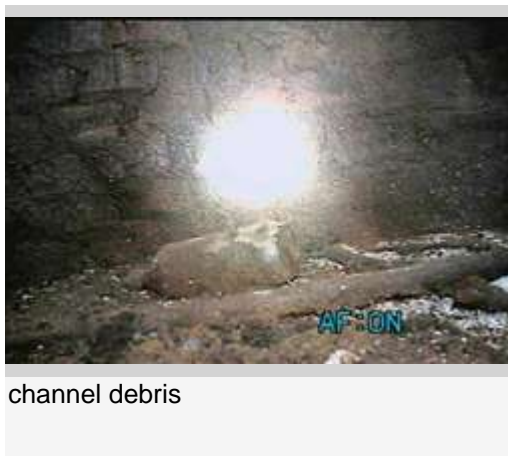
Defect 2

☒ **Debris**

channel debris

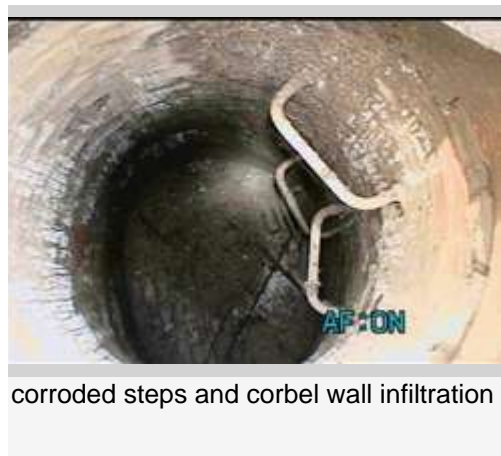
Defect 3

☒ **Wall**

☒ **Corroded**

corroded steps and corbel wall infiltration

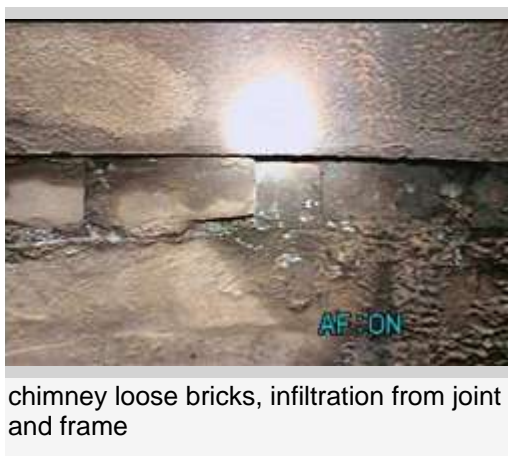
Defect 1

☒ **Leaks**

☒ **Loose Brick**

☒ **Joint**

chimney loose bricks, infiltration from joint and frame

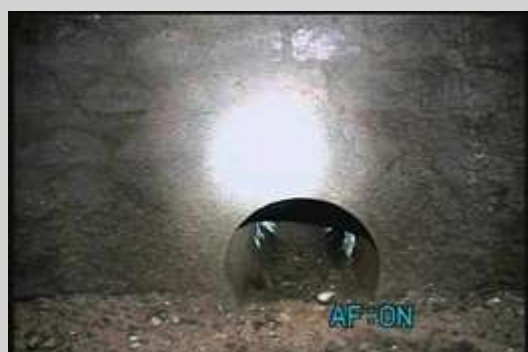
12 O'Clock Outflow

8 in. Circular Gravity Sewer
Pipe Out @ 12 O'Clock
